NASA TM X-73919

**CONCORDE NOISE-INDUCED BUILDING VIBRATIONS FOR
SULLY PLANTATION
CHANTILLY, VIRGINIA**

June 1976

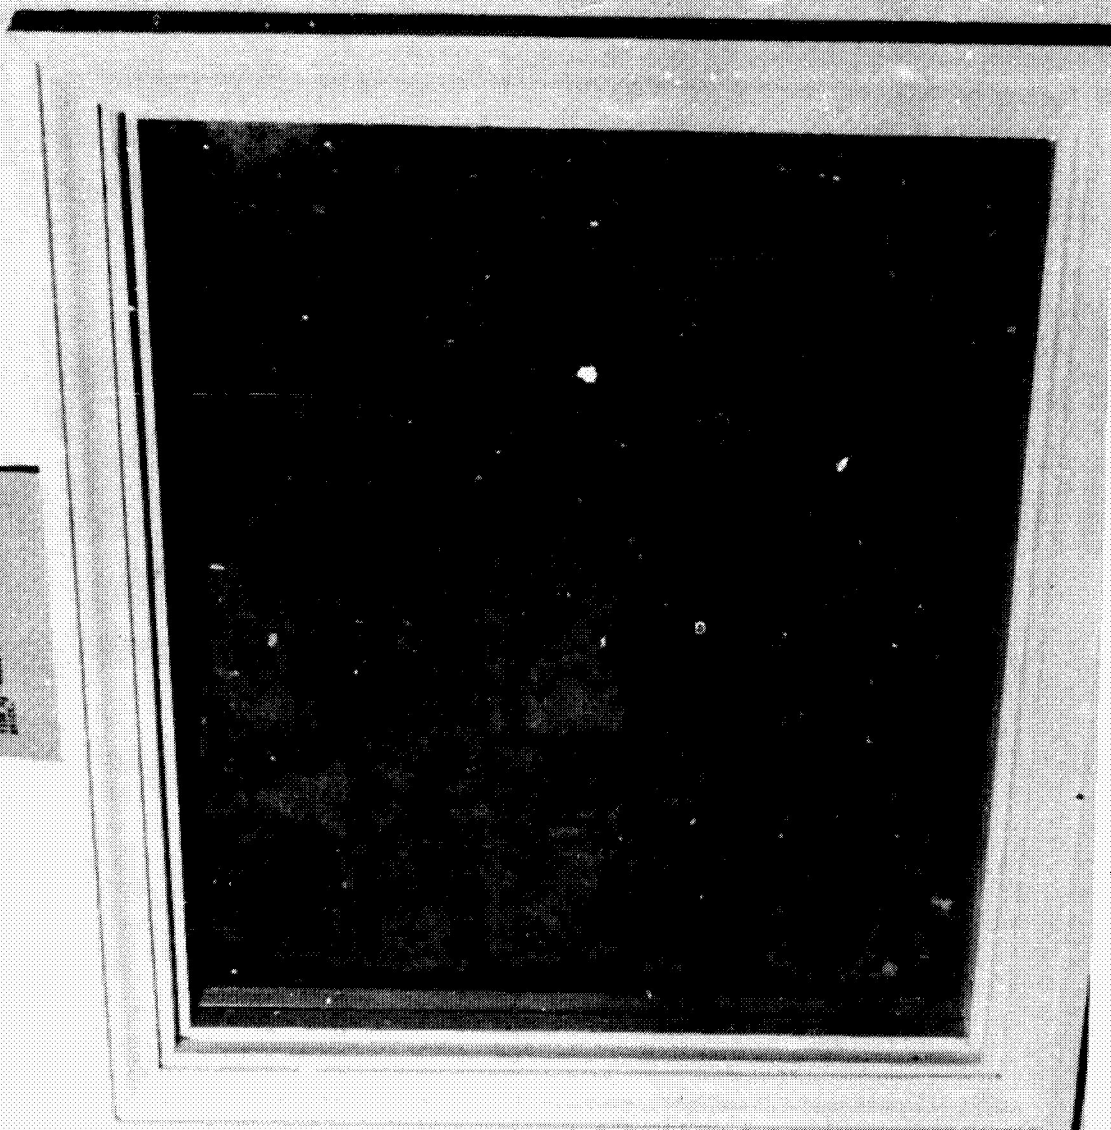
Figure 3.- Cutaway wall section showing "nogging" construction.

Figure 2 is a photograph of the south elevation of Sully Plantation. As described in reference 3, the building is a two and one-half story central section flanked by asymmetrical one and one-half story gabled wings. Its foundation of red sandstone, averaging almost 2 feet in thickness, support walls which are sheathed by clapboards that cover a heavy mortise-and-tenon framing. The walls of the earliest portion of the house are insulated by means of the common 18th century "nogging" (filled with brick). Figure 3 shows a section of wall which has been cut away to reveal the nogging. The nogging is covered with lath (figure 4) and three layers of plaster. Random width pine flooring attached directly to floor joists is used throughout the house (no subfloor). Windows are generally the 12 over 12 sashing type with some being of 9 over 9, 6 over 9, and 6 over 6. Of the 324 window panes at Sully, half are original and a typical pane measures 20.3 cm by 25.4 cm and varies from 0.16 cm to

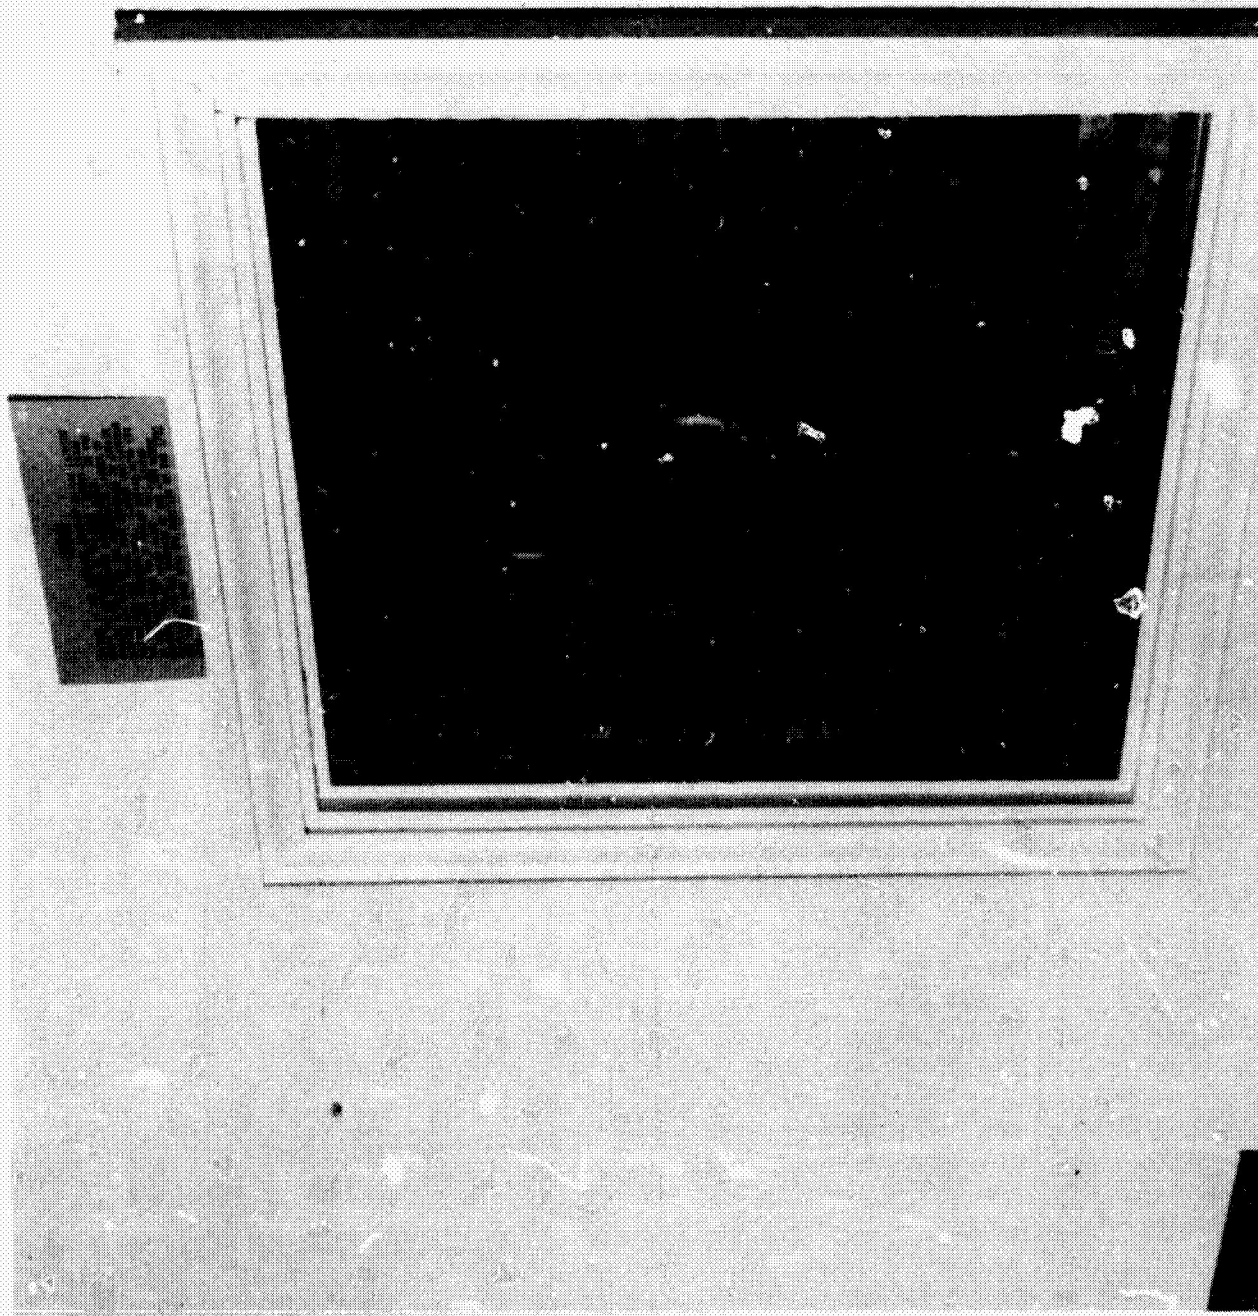
Figure 4.- Cutaway wall section showing plaster lath.

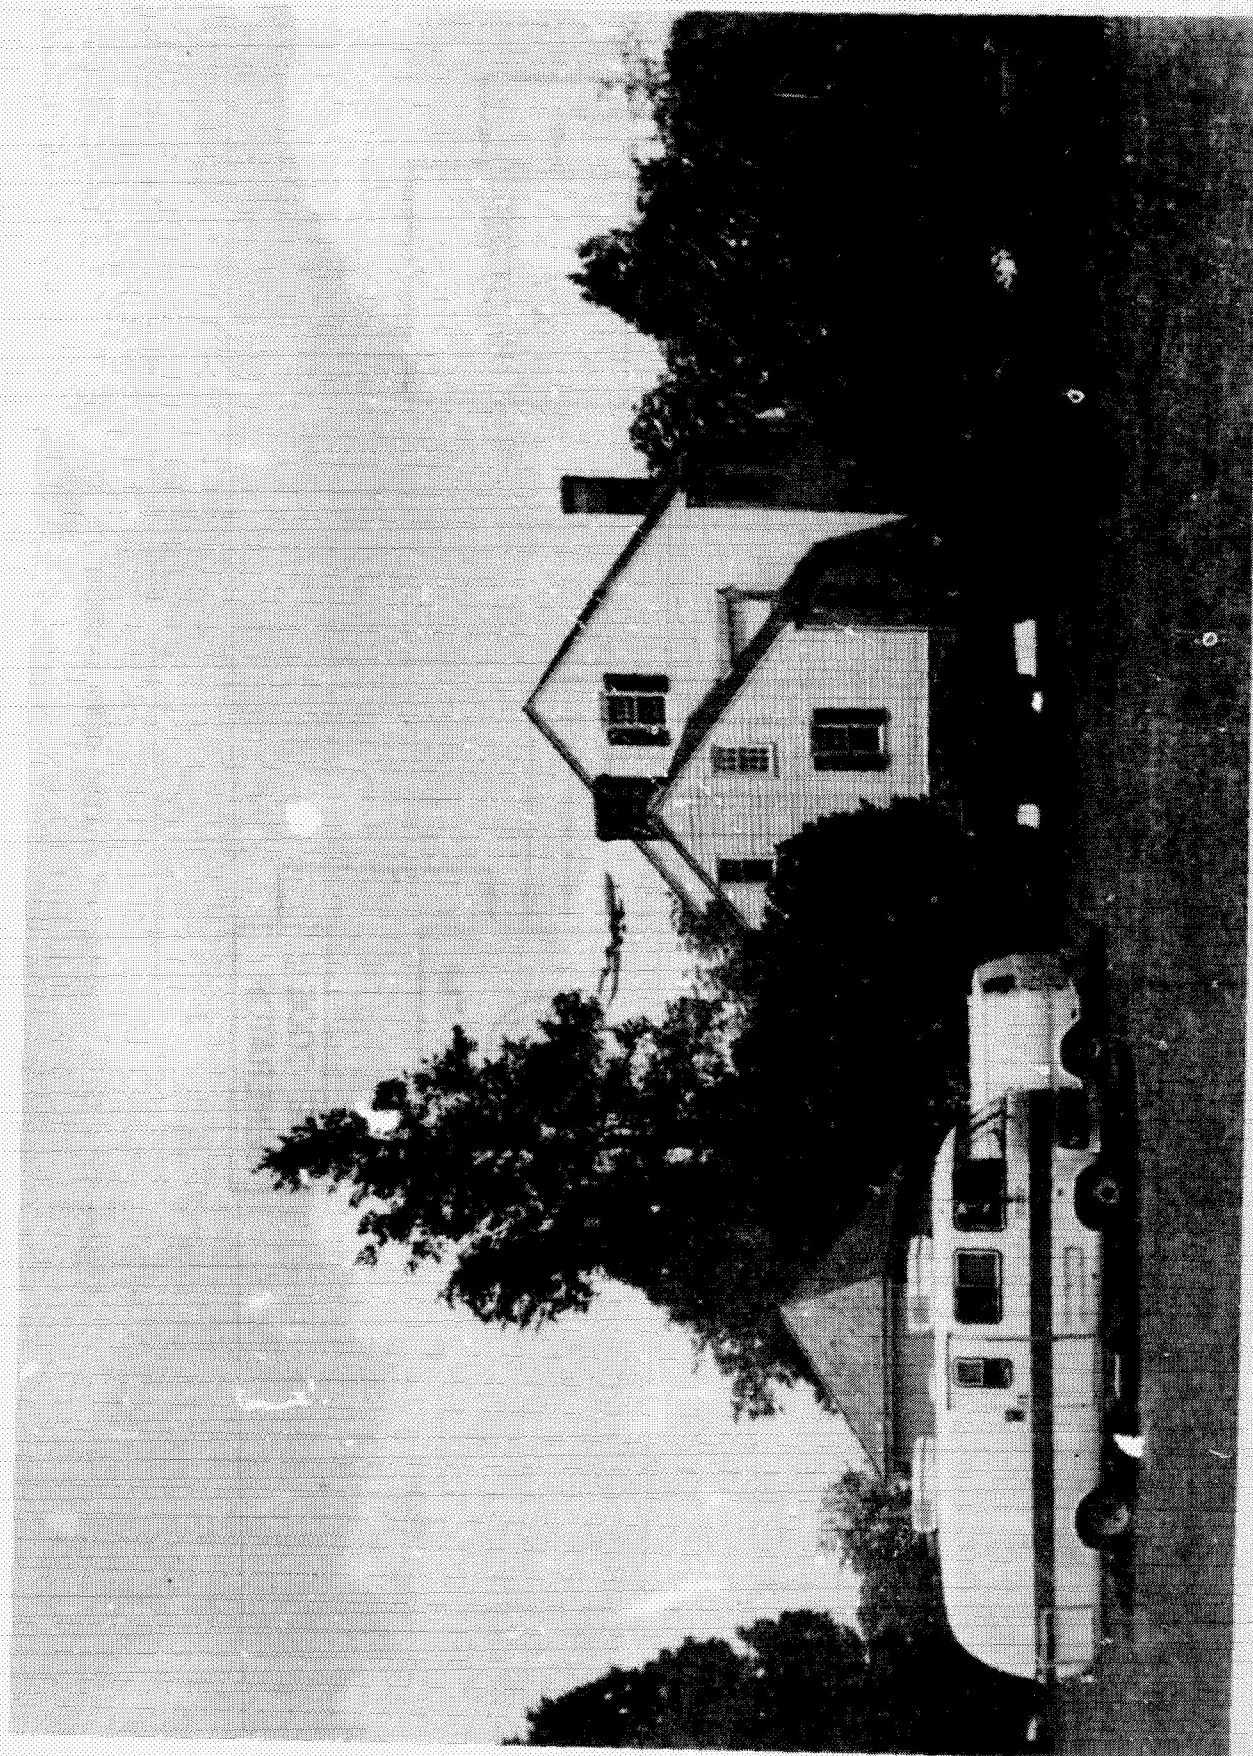
Figure 9.- Mobile data acquisition systems at Sully Plantation.

Two mobile instrument systems were employed, one completely analog operated under contract by Wyle Laboratory personnel supporting measurements in the south room and a second, containing both an analog capability as well as an online digital processing system, supporting the north room. Figure 9 shows both vehicles as they were deployed at Sully Plantation and figures 10 and 11 are block diagrams of the respective instrument systems. The analog data acquisition equipment in both vehicles was virtually identical. Acoustic measurements of both inside and outside sound pressure levels were made using conventional Bruel and Kjaer measuring equipment. Vibration data were obtained from piezoelectric crystal accelerometers mounted on the floor, wall, and window of each room and processed with in-house developed signal conditioning electronics. All data were recorded on analog FM tape so that subsequent spectral analysis or specialized weighting functions could be applied to the data as the need or interest dictates. Online analog x-y plots of window vibration response versus outside sound pressure level were obtained in each vehicle; a typical plot for the Air France takeoff may be found in figure 12. In the larger vehicle, a General Radio 1926 (multichannel, true rms) log voltmeter was employed to sample, analog-to-digital convert, average, and log convert each of the five signals into overall readings (each 1/2-second) for subsequent digital processing. A Hewlett-Packard 21M20 digital computer was then used to format these data into line prints of the time history values and to provide "Calcomp" plots of the acoustic time histories of both inside and outside overall sound pressure levels as well as plots of selected
